**TRANSPORTATION SCIENCES  
CRASH DATA RESEARCH CENTER**

Veridian Engineering  
Calspan Operations  
Buffalo, New York 14225

**CALSPAN ON-SITE AIR BAG RELATED CHILD FATALITY INVESTIGATION  
CALSPAN CASE NO. CA96-010  
VEHICLE - 1996 DODGE CARAVAN SE  
LOCATION - TENNESSEE  
CRASH DATE - 1996**

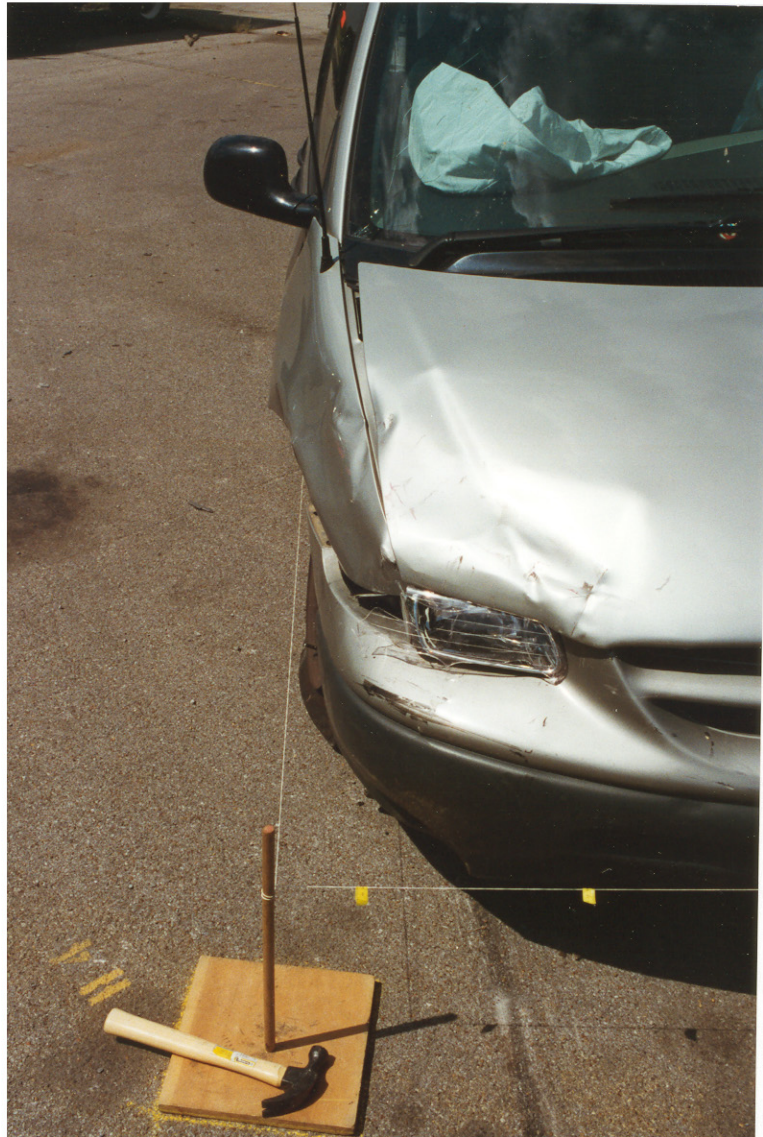
The 1996 Dodge Grand Caravan SE sustained moderate damage to the front right area of the vehicle as a result of its impact sequence with the left front side area of the 1988 Mercury Cougar. The direct contact damage began 12.7 cm (5.0 in) right of center and extended 66.0 cm (26.0 in) to the front right corner. Maximum residual crush was 3.3 cm (1.25") located at the right corner of the bumper reinforcement bar. The documented crush profile over the full width of the reinforcement bar was as follows: C1=0, C2=0, C3=0, C4=0.6 cm (0.25 in), C5=1.0 cm (0.38 in), C6=3.3 cm (1.25 in). Damaged components included the front bumper fascia, bumper reinforcement bar, hood, right headlamp assembly, and the right front fender.

28. Frontal damage to the Dodge Caravan.

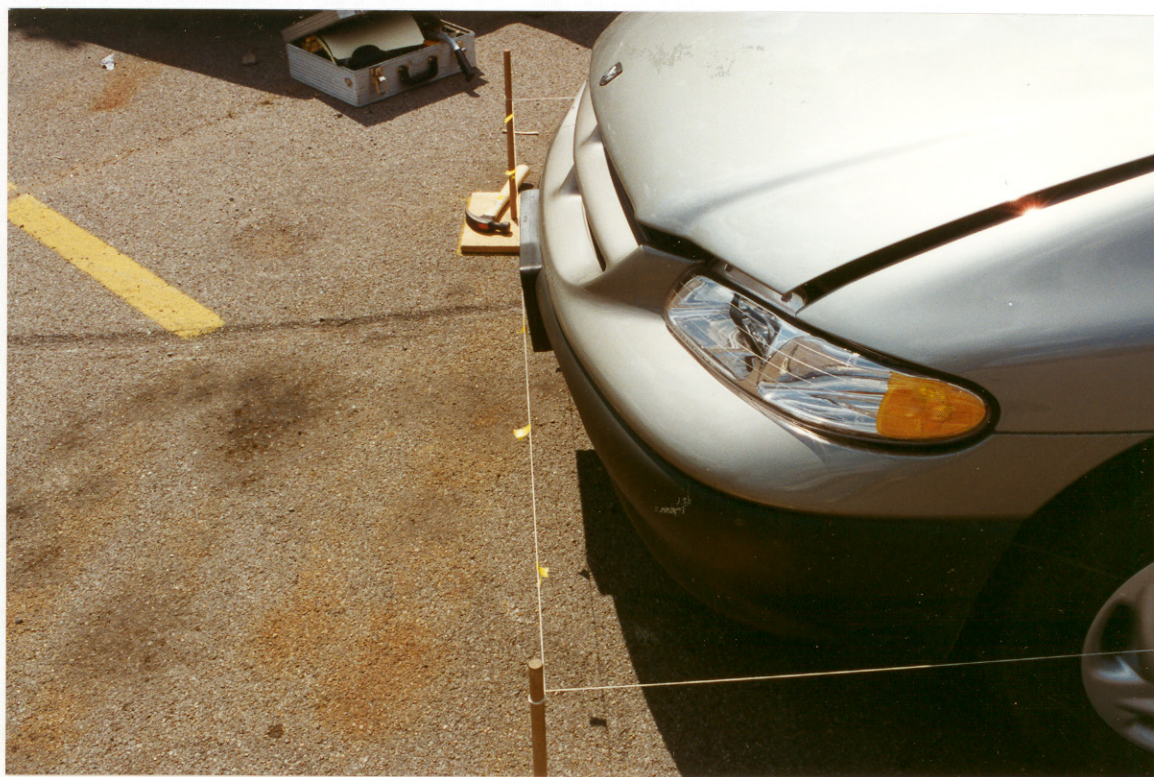
30. View of the direct contact damage to the Dodge Caravan.

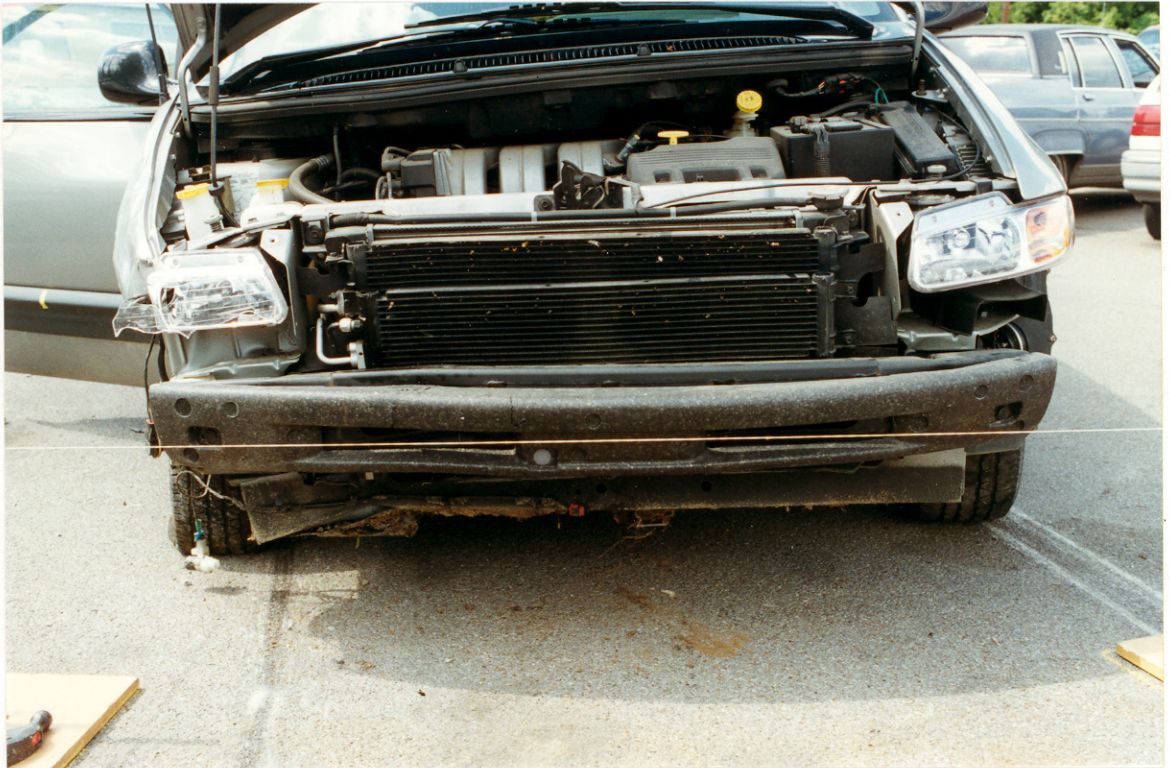
31. Left lateral view of the frontal crush to the Dodge Caravan.

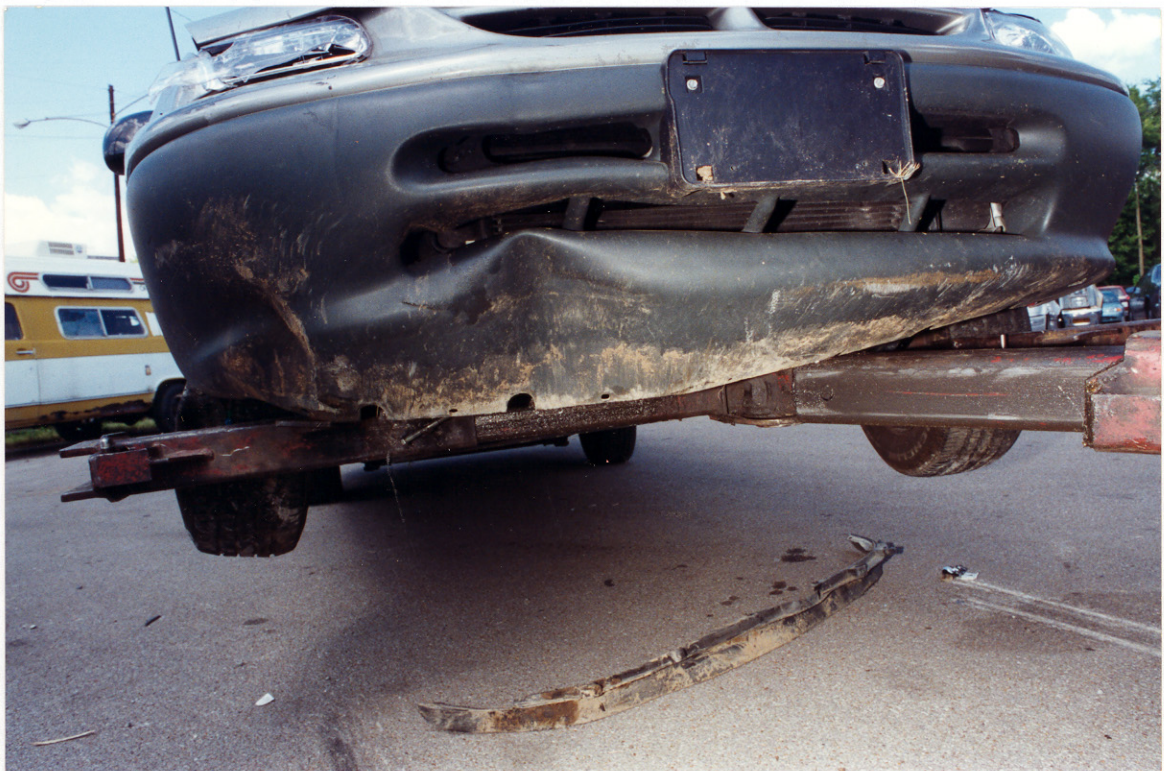
As the Caravan came to rest, the front right undercarriage area impacted a drainage ditch which abraded the underside of the bumper fascia. The contact damage began at the right corner of the fascia and extended 115.6 cm (45.5 in) to the left. The air dam aspect of the fascia was displaced upward approximately 3.8 cm (1.5 in).

34. Front view of the damage to the lower surface of the bumper fascia.

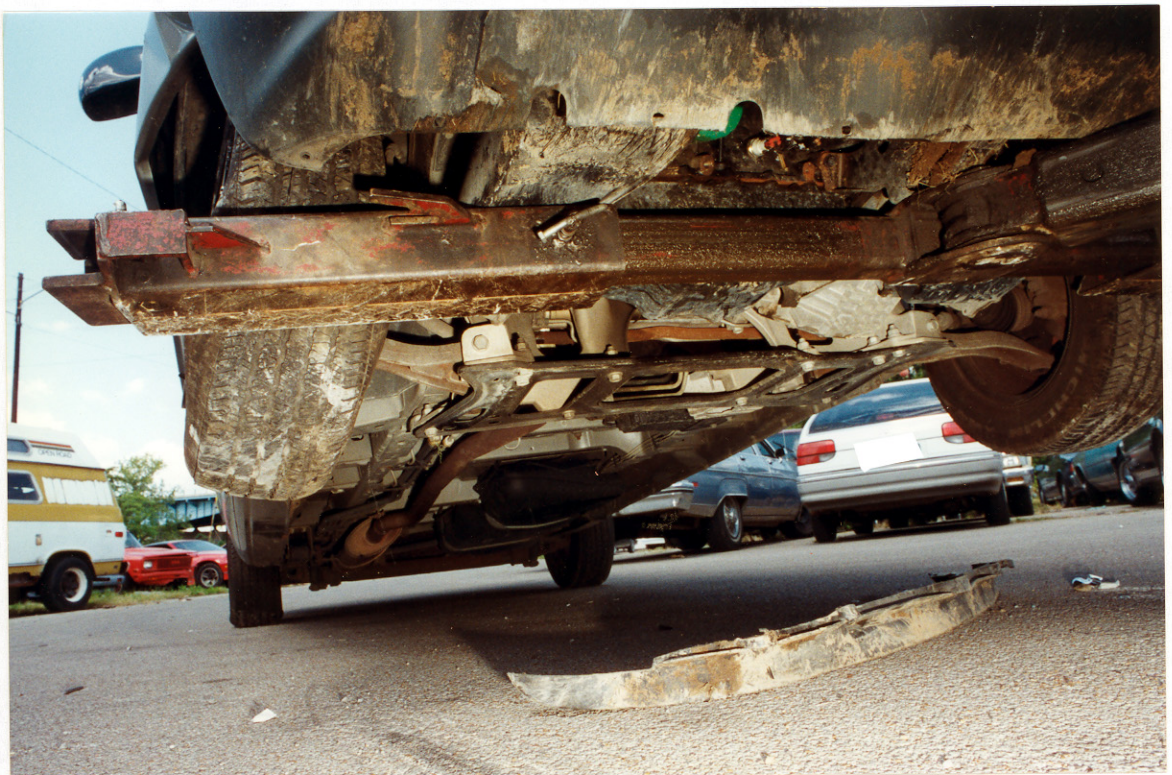
36. Close up view of damage to the lower surface of the bumper fascia.

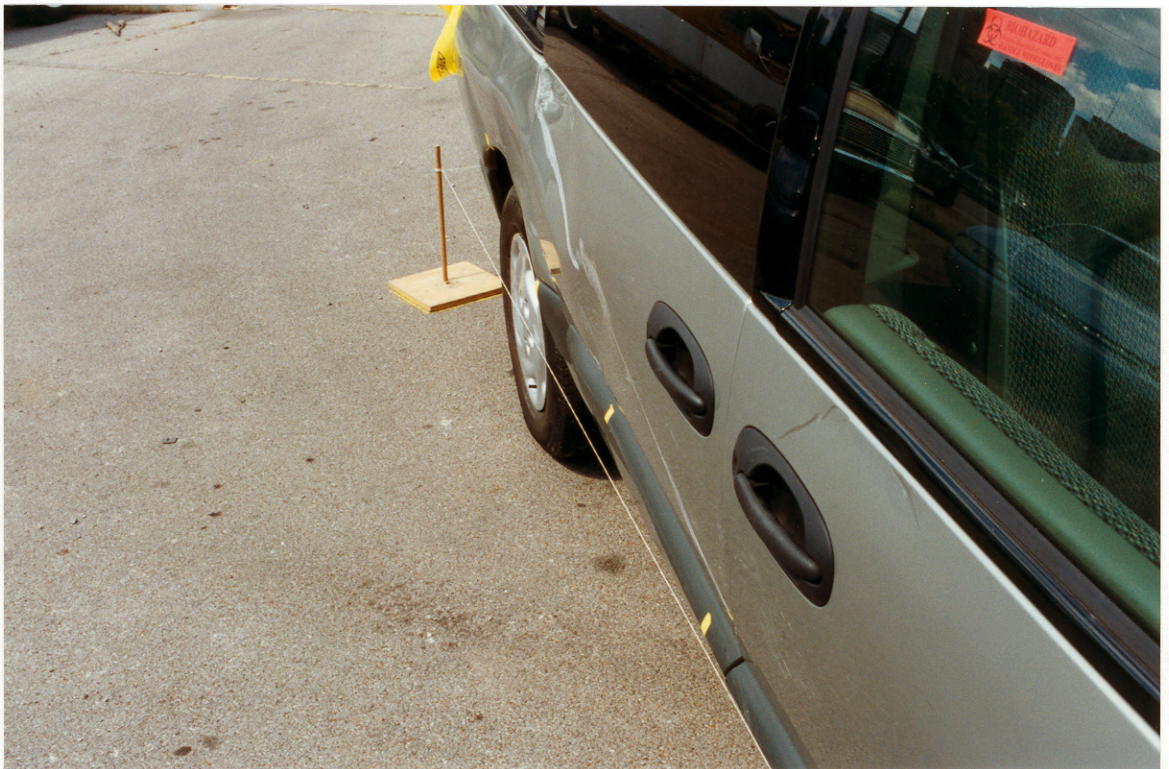
Secondary damage resulted from a subsequent sideslap impact with the Mercury Cougar. The direct contact damage began 66.8 cm (23.6 in) aft of the right rear axle and extended forward 265.4 cm (104.5 in). A maximum lateral deformation of 3.2 cm (1.25 in) was located 54.6 cm (21.5 in) forward of the right rear axle at the base of the C-pillar. The superficial crush profile was as follows: C1=0 cm, C2=1.9 cm (0.75 in), C3=0.6 cm (0.25 in), C4=1.3 cm (0.5 in), C5=0 cm, C6=0 cm.

44. Right rear side slap damage to the Dodge Caravan.

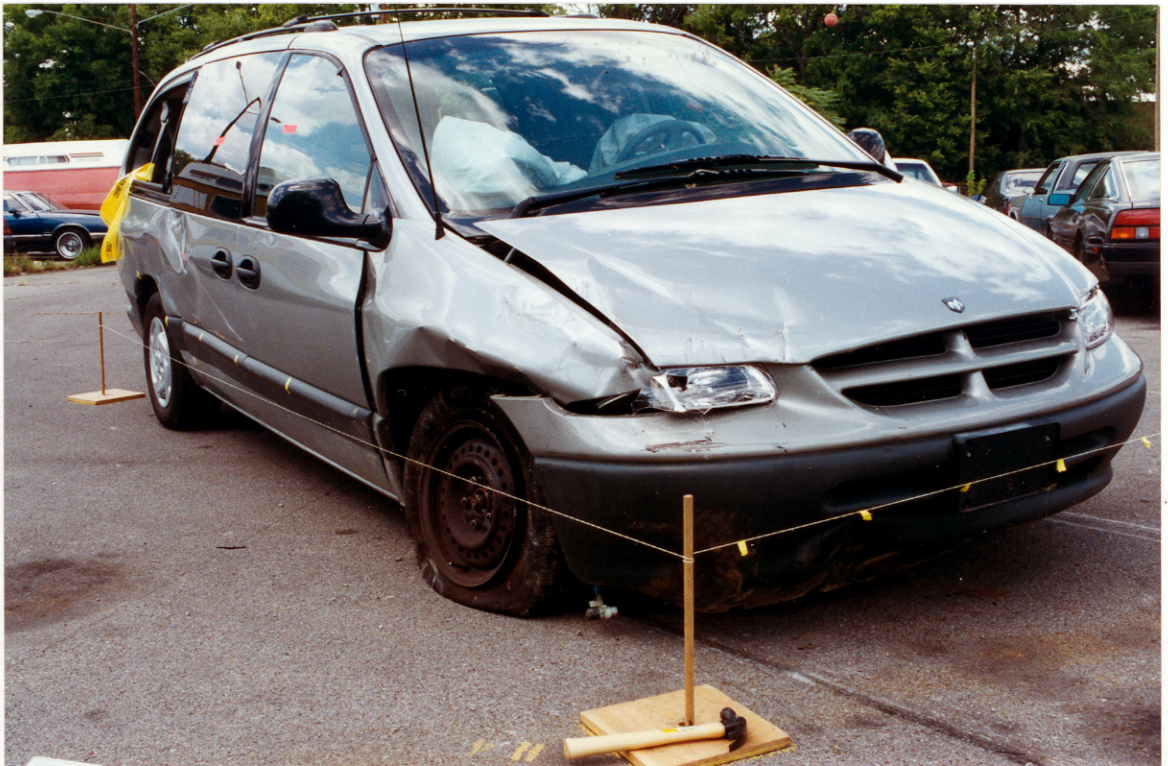
45. View of the right side direct contact damage.

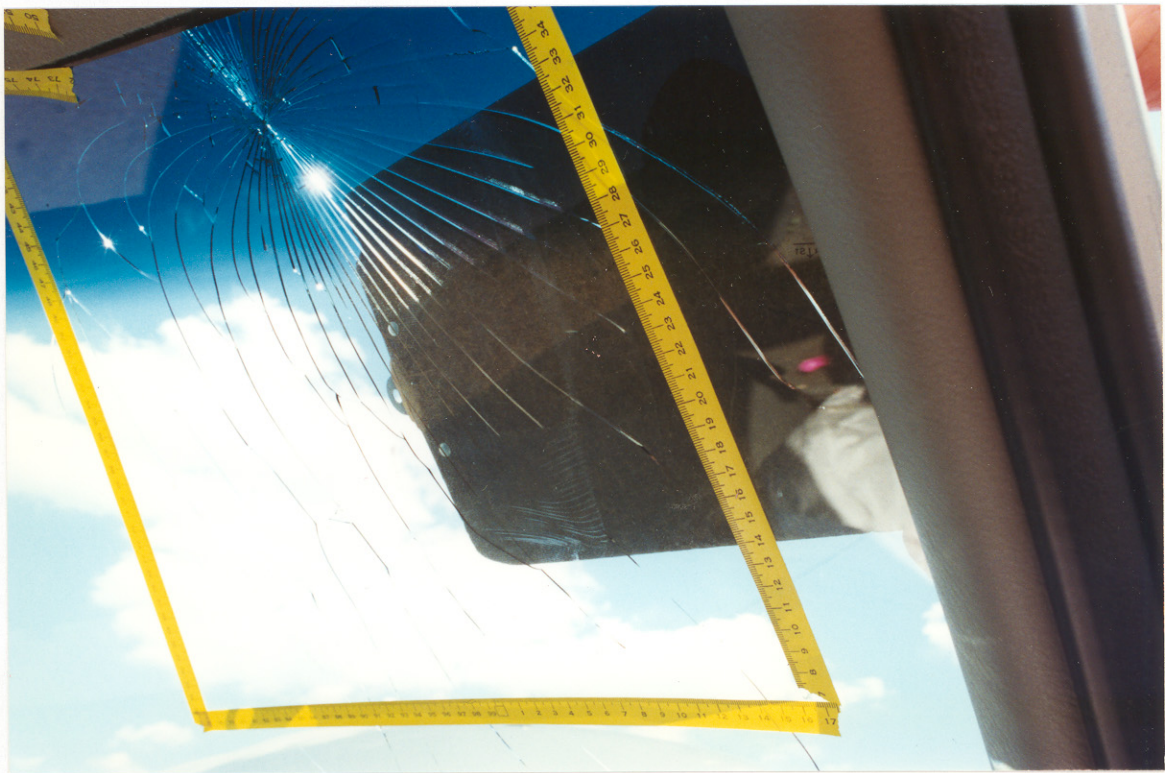
The forward position of the child occupant pre-crash, altered the normal deployment path of the air bag, deflecting the bag upward into the windshield and rearview mirror. Bag contact with the glazing was evidence by air bag fabric transfers on the glass and a fracture to the windshield. The rearview mirror was subsequently separated from its mount and displaced to the left.

65. Overall view of the windshield fracture caused by the deploying passenger side air bag.

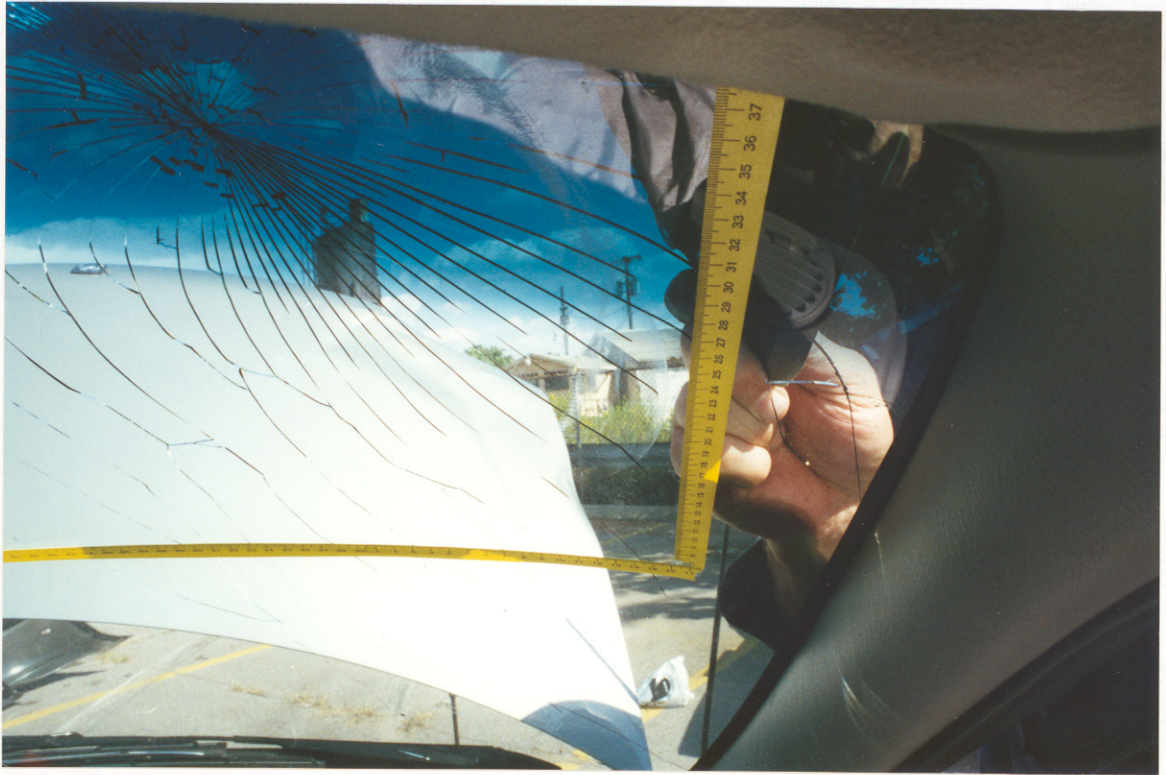
66. Right view of the windshield fracture and air bag fabric transfers.

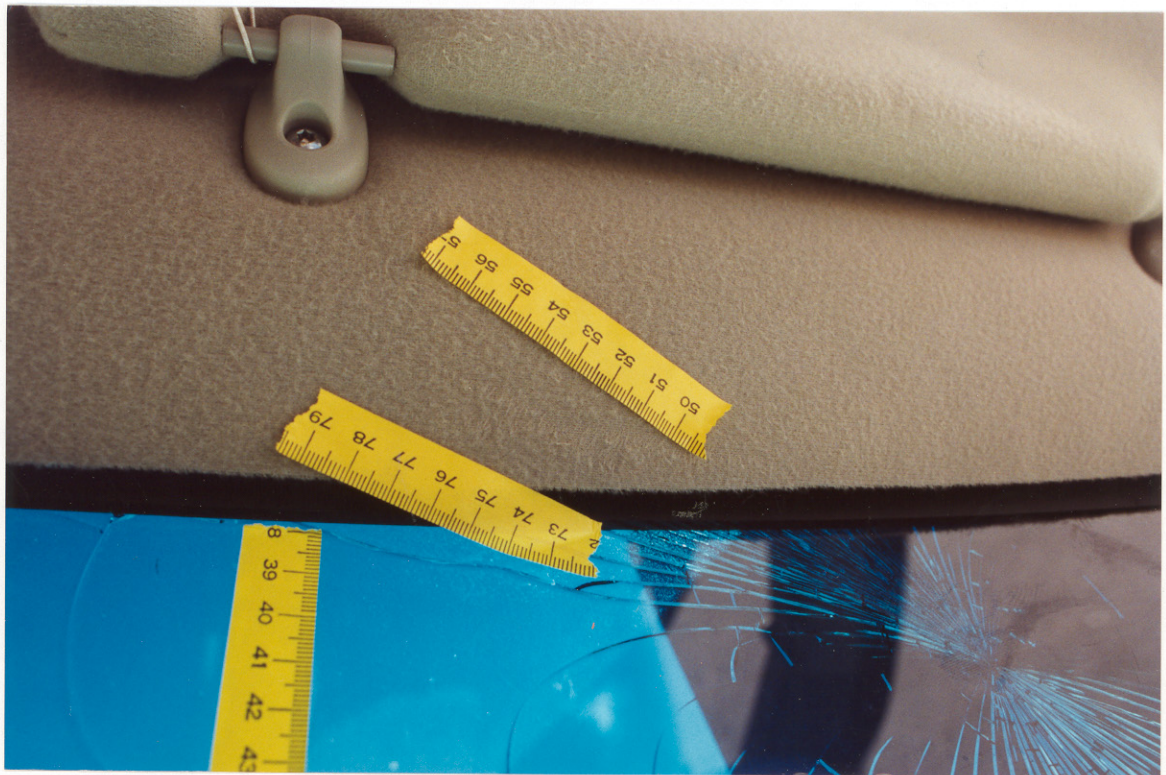
67. Close-up view of the windshield fracture and the air bag fabric transfers.

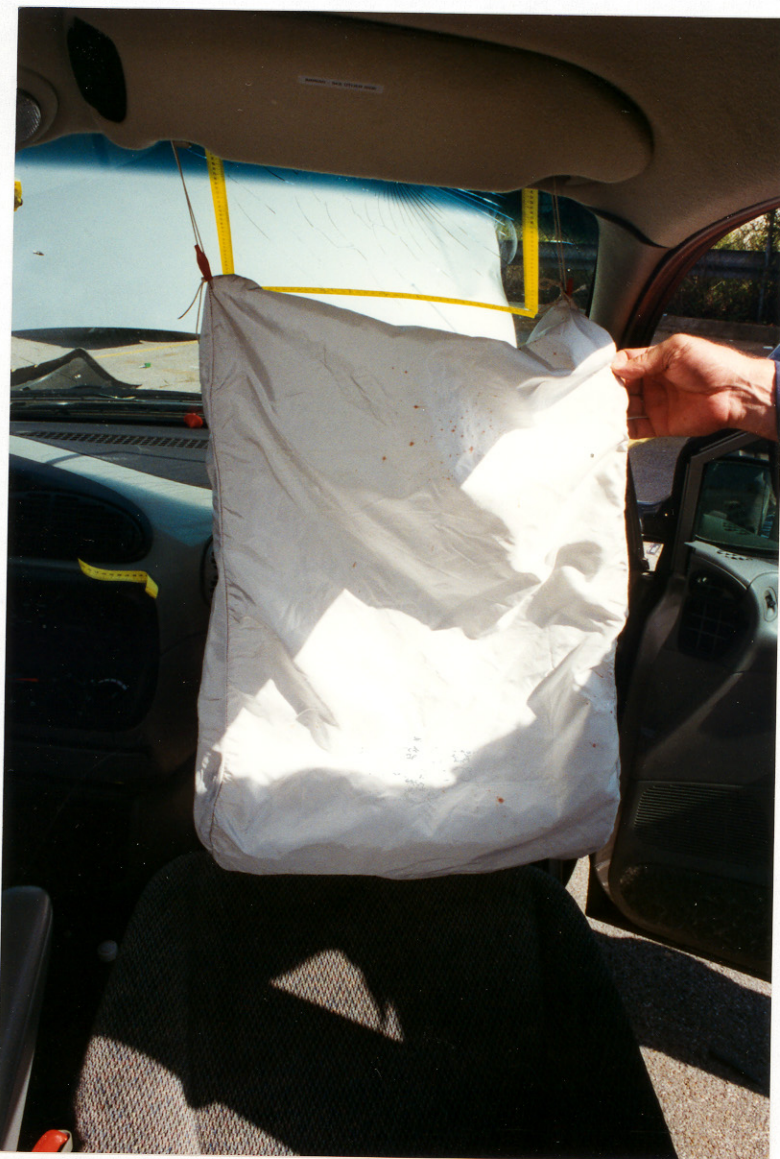
The deployment path of the passenger side air bag was altered by the forward position of the front right child passenger which resulted in bag contact to the windshield, headliner, and the rear view mirror. A large air bag fabric transfer was located to the windshield 35.6-54.6 cm (14.0-21.5 in) right of the vehicle's centerline and 2.5-31.8 cm (1.0-12.5 in) below the windshield header (refer to Photograph No. 66). A windshield spider web-type cracked was located 41.3 cm (16.25 in) right of center and 5.1 cm (2.0 in) below the headliner (refer to Photograph No. 65-67). Also, an air bag fabric abrasion was located on the headliner 27.9-33.0 cm (11.0-13.0 in) right of center which extended 1.3-5.1 cm (0.5-2.0 in) rearward (refer to Photograph No. 68).

68. Close-up view of a fabric abrasion on the header/headliner.

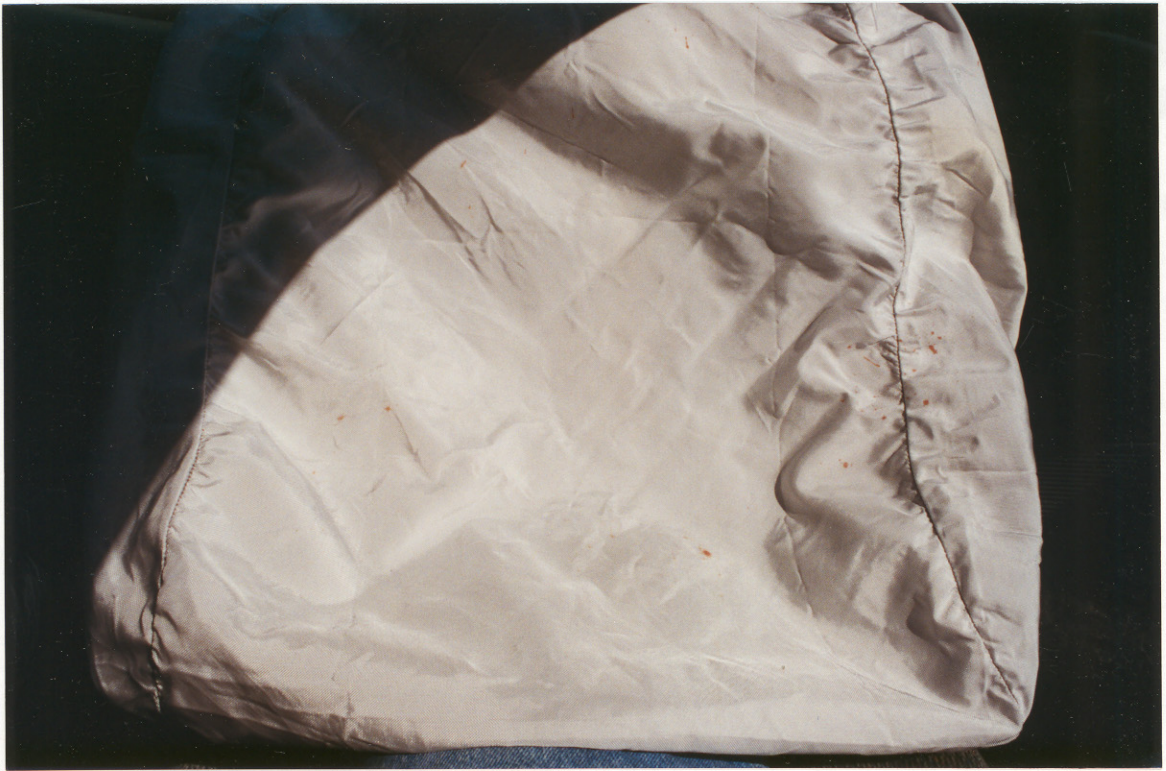
Three blood spatter patterns were located on the face of the front right passenger air bag. The first spatter was located 17.8-38.1 cm (7.0-15.0 in) inboard of the left side of the air bag and 7.6-20.3 cm (3.0-8.0) below the top of the bag. The second blood spatter was noted 30.5-38.1 cm (12.0-15.0 in) below the top of the bag and 0.0-5.1 cm (0.0-2.0 in) inboard of the right side of the bag. A third blood spatter was 54.6-58.4 cm (21.5-23.0 in) below the top of the bag and 14.0-21.6 cm (5.5-8.5 in) inboard of the right side. The Medical Examiner suspected that the spatters possibly resulted from the dislocation of a tooth from the child passenger. An additional trail of blood spatters were noted to the headliner above the front right seat (refer to Photograph No. 77). A body material (tissue or nasal expulsion) transfer which measured 12.7 cm (5.0 in) was located on the right side of the passenger air bag, centered between the side seams and 7.6 cm (3.0 in) above the lower seam.

72. View of the blood spatters on the center and right side of the passenger air bag.

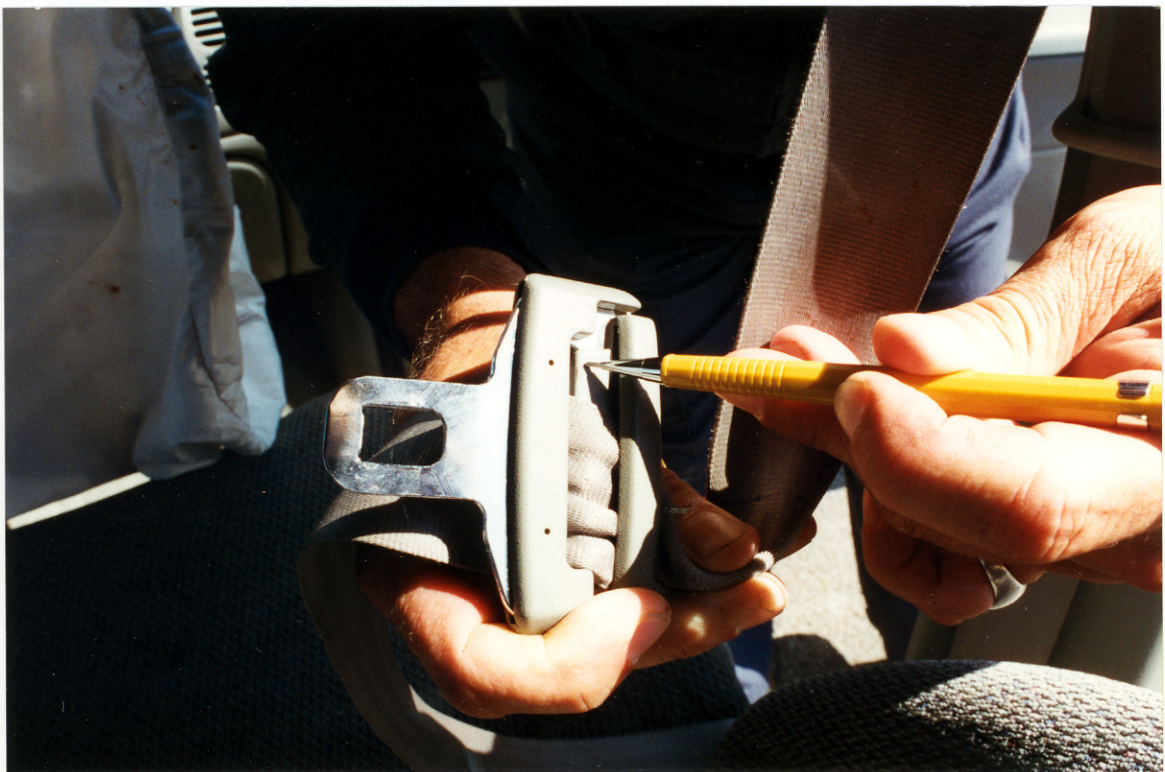
Additional transfers included a stain-like mark on both sides of the front right seat belt webbing 88.9-113.0 cm (35.0-44.5 in) above the floor anchorage. Also, eight (8) small blood spatters were noted to the outside edge of the shoulder belt webbing and were located 90.8-100.3 cm (35.75-39.5 in) above the floor anchorage. With the system buckled, these transfers would be approximately 5.1-15.2 cm (2.0-6.0 in) above the latchplate.

87. View of blood spatters on the right front restraint webbing.

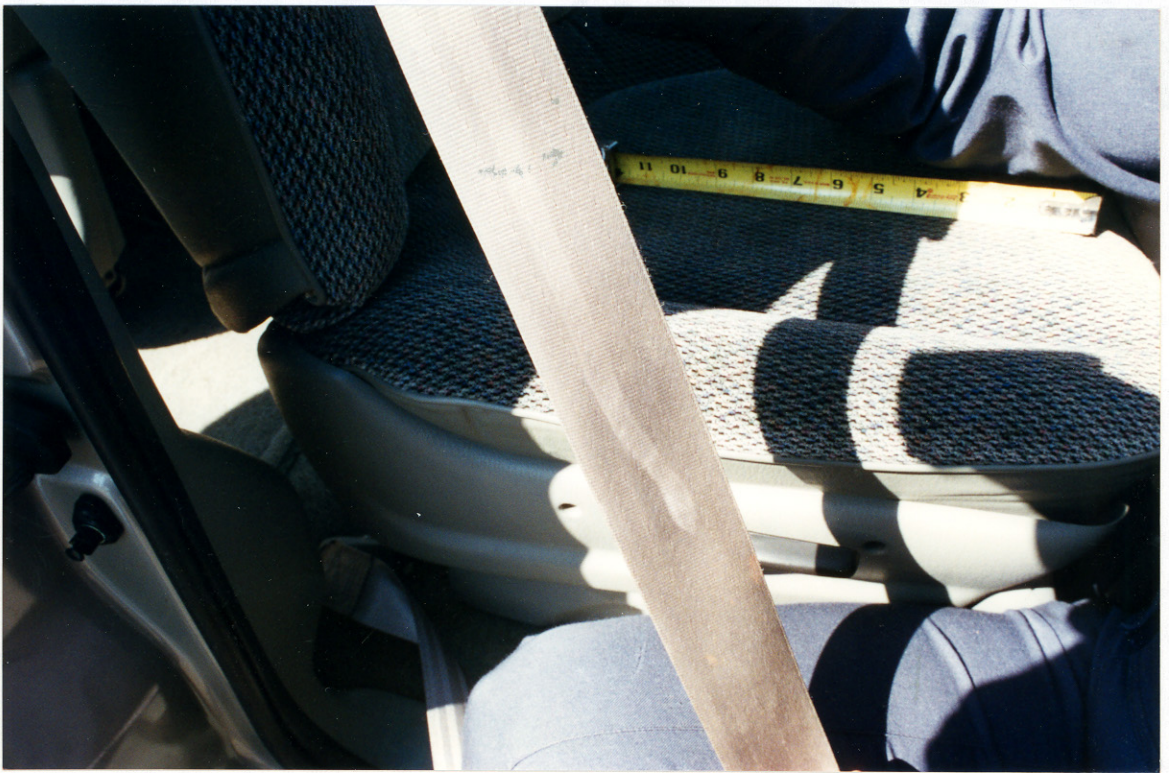
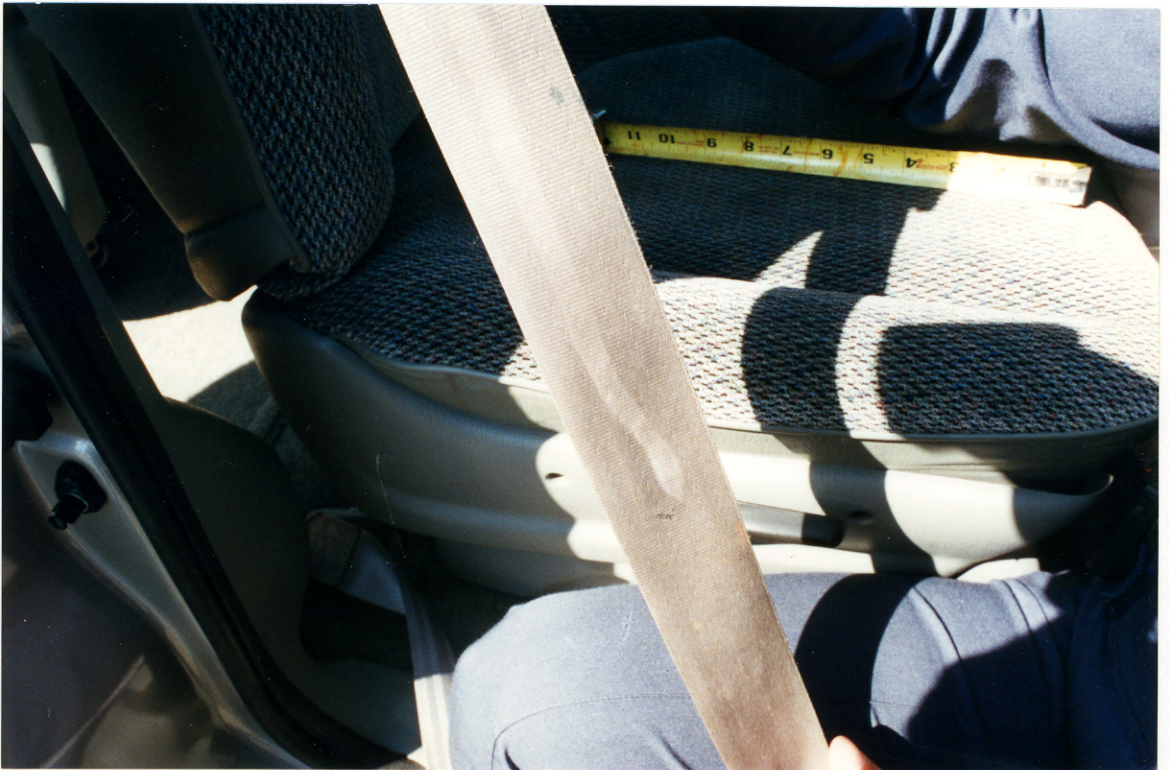
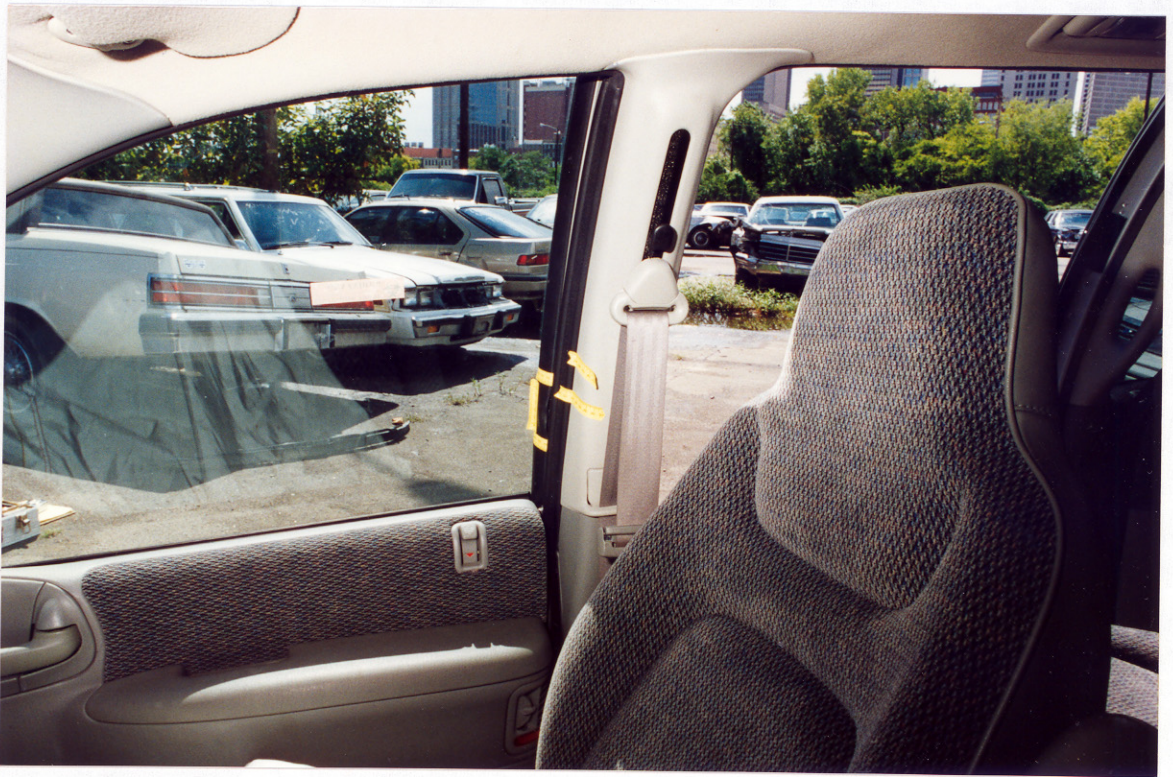
The 5 year old child passenger was seated in the right front position and was restrained by the lap portion of the restraint with the shoulder belt probably positioned behind her back. The right front D-ring was adjusted to the full down position (refer to Photograph No. 85). A faint abrasion was noted on the outboard aspect of the plastic crossbar of the latchplate (refer to Photograph No.88). There were blood stains noted 7.6-15.2 cm (3.0-6.0 in) outboard of the latchplate on the lap portion of the webbing. There were also eight (8) small blood stains noted on the shoulder aspect of the belt webbing (refer to Photograph N. 87). The stains were located 5.1-15.2 cm (2.0-6.0 in) above the latchplate. These stains probably were deposited after the child rebounded back under the shoulder belt webbing in the later stages of the crash sequence. A fluid spill was also noted on the right front restraint webbing (refer to Photograph Nos. 89-92), however, this did not appear to be related to the crash.

90. View of a fluid spill on the right front restraint webbing.

91. View of a fluid spill on the right front restraint webbing.

92. View of the fluid spill. Note, this is the reverse side of the webbing.

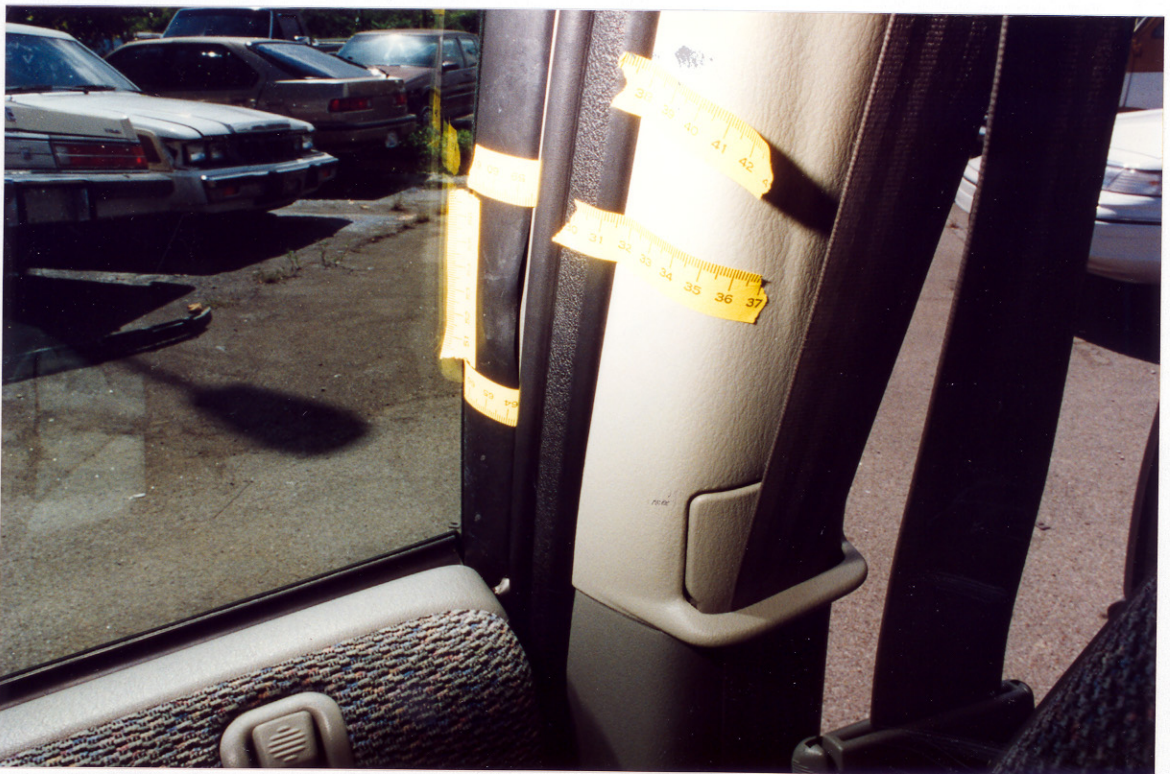
The posterior scalp of the front right child passenger impacted the right upper B-pillar and door window frame during her rebound trajectory. The rubber strip at the trailing edge of the right front door window was deformed by the head contact. The deformed area of the gasket involved 5.0 mm (0.2 in) of compression. The compression was located 11.1-13.7 cm (4.4-5.4 in) above the beltline and 47.0 cm (18.5 in) above the seat cushion (refer to Photograph No.93-95). A dark oily smudge was noted on the B-pillar 17.1-18.4 cm (6.75-7.25 in) above

93. View of a rebound contact at the right B-pillar/window juncture.

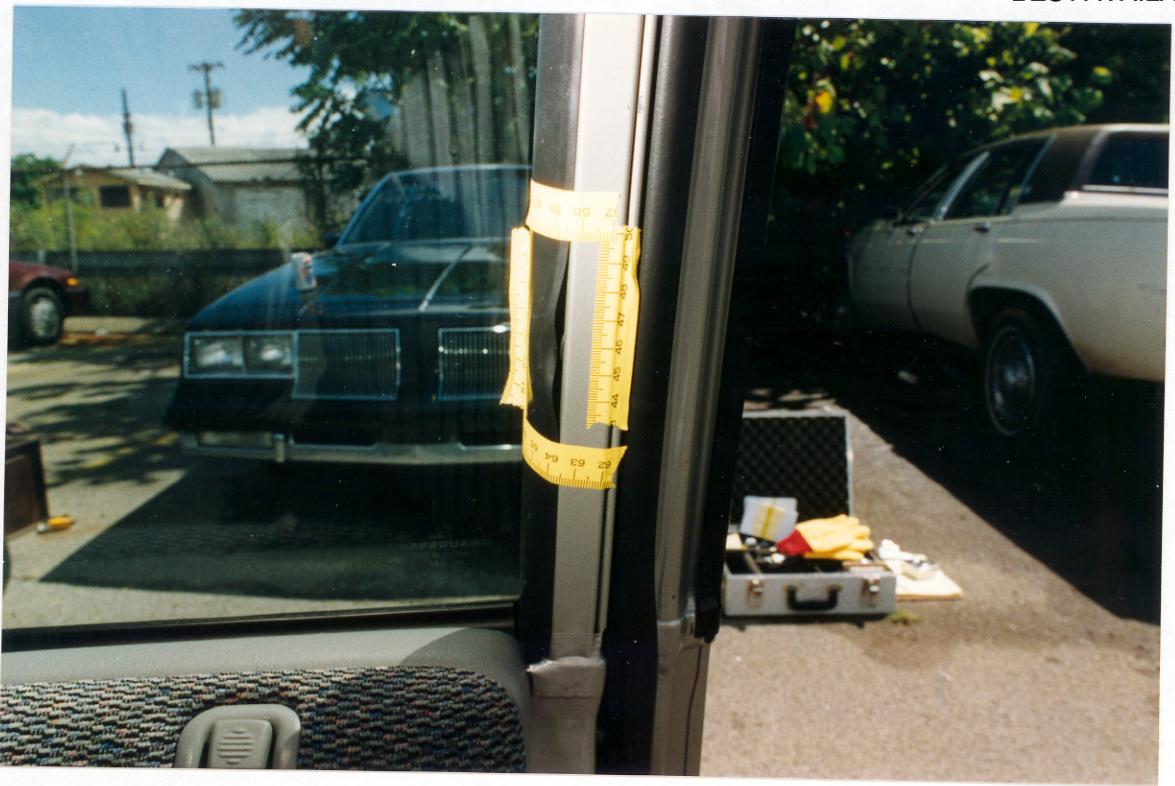
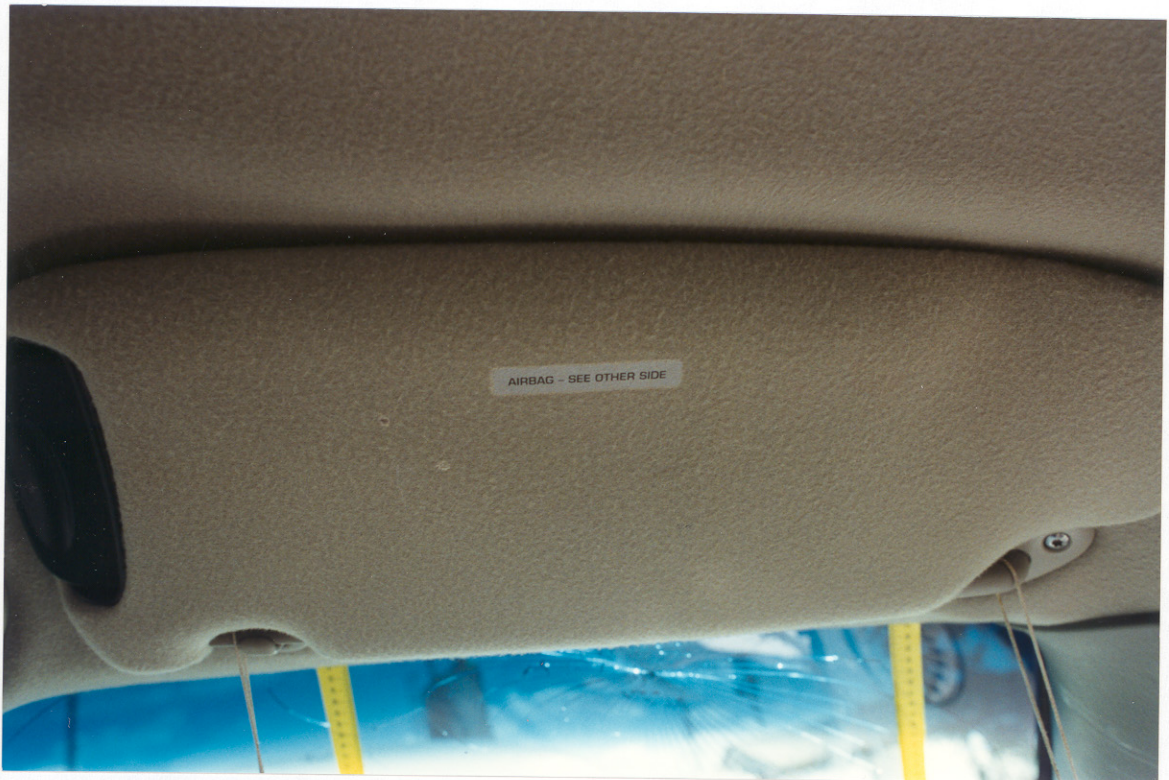
94. Close-up view of the rebound contact.

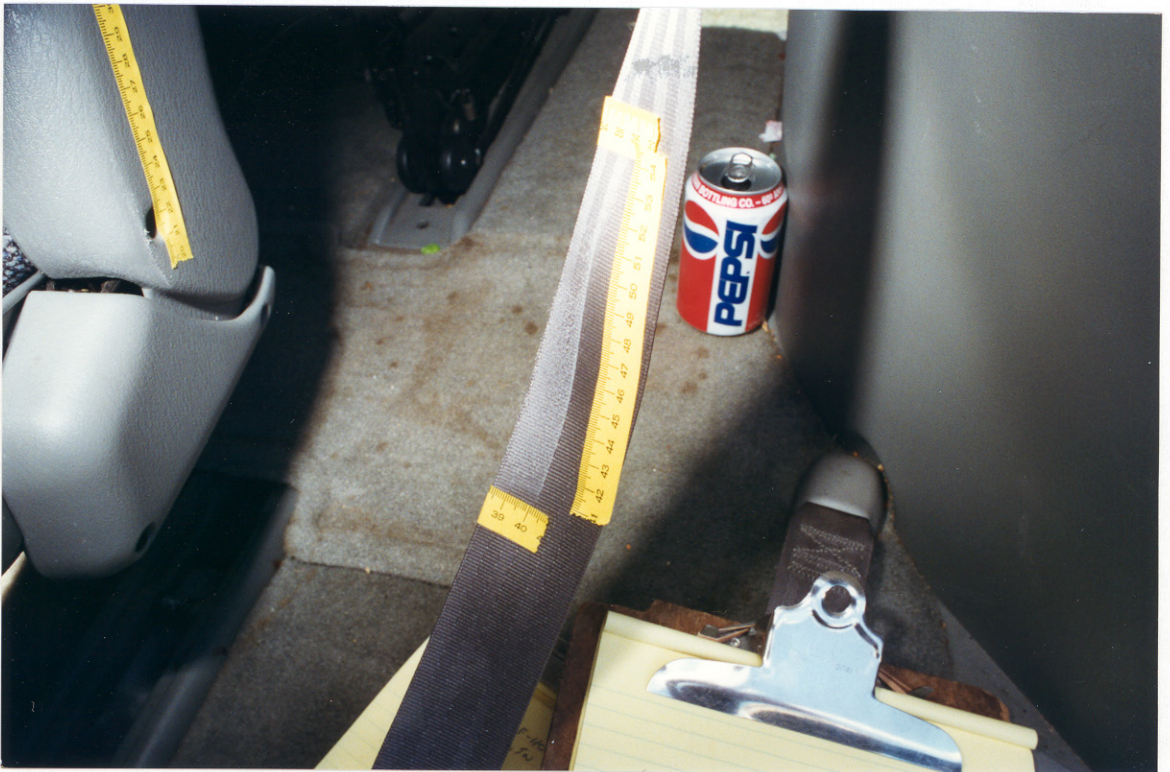
child safety seat on the seat cushion. Abrasions were noted to the shoulder belt webbing and to the plastic extrusion at the seat cushion/seat back juncture. In addition, the loading produced a D-ring transfer to the shoulder belt webbing. This evidence is documented in Photograph Nos. 97-102.

101. Close-up of an abrasion on the upper portion of restraint webbing near the D-ring.

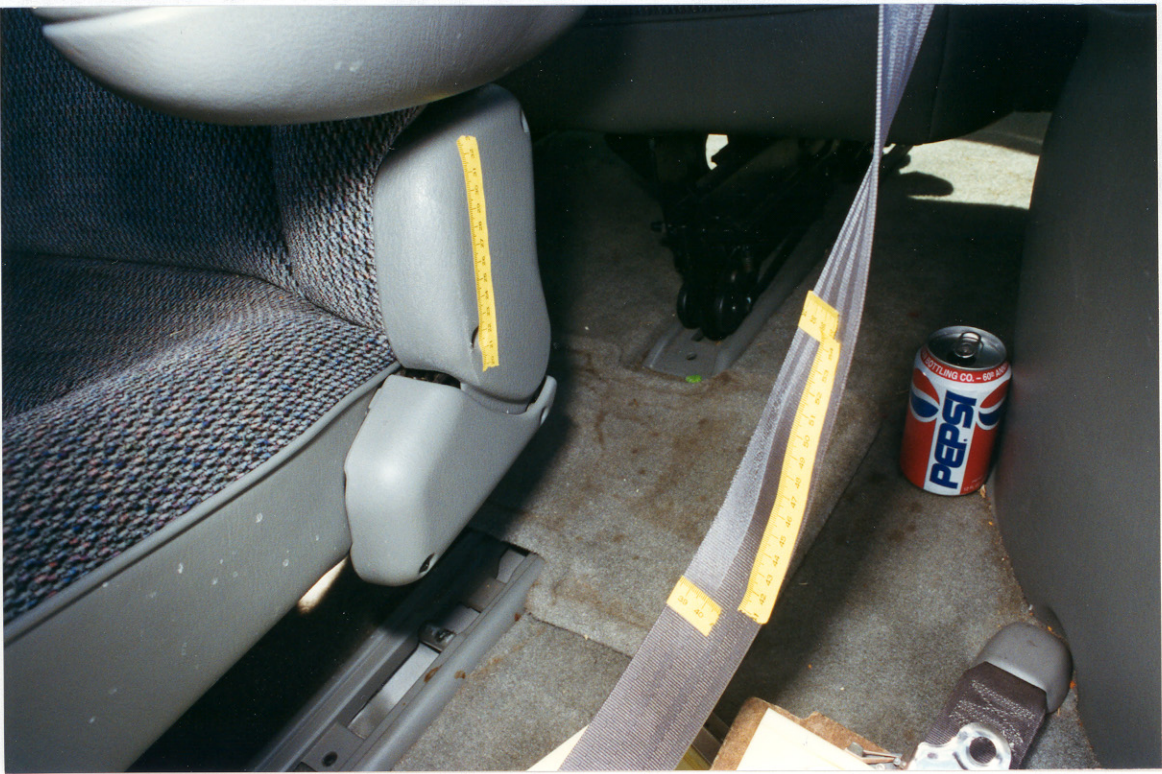
102. Close-up of an abrasion on the restraint webbing caused by the plastic cover.

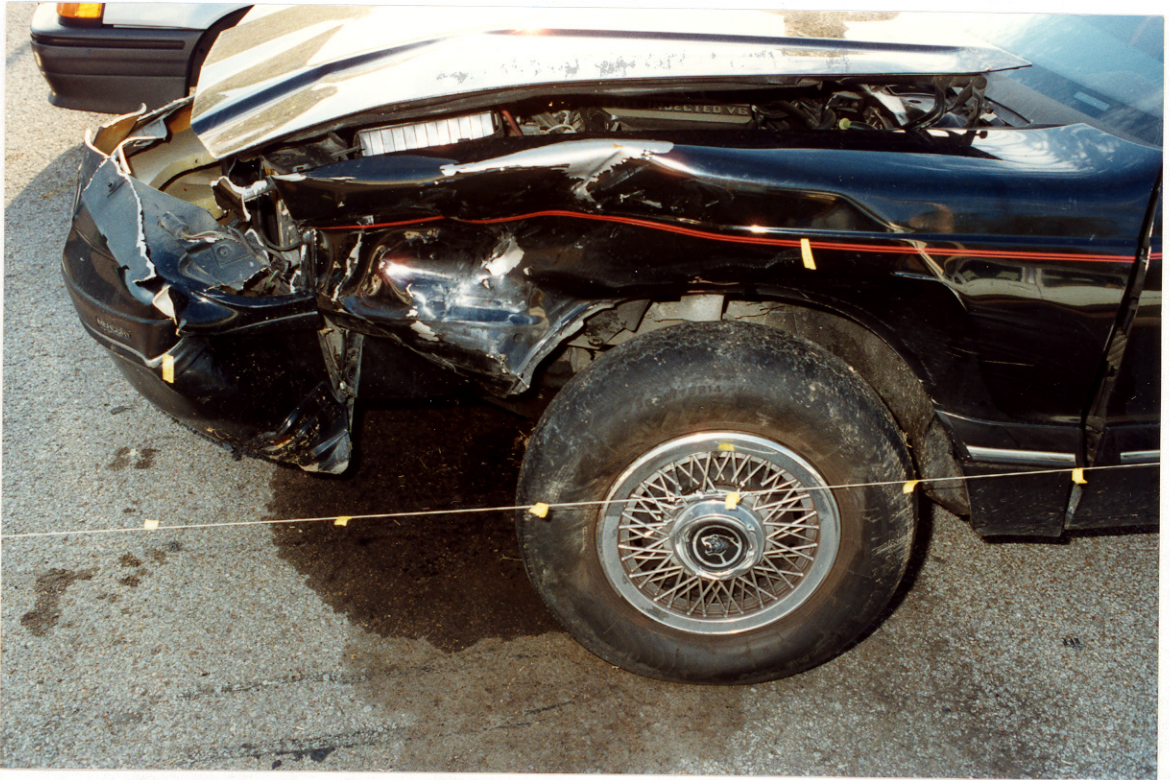
The 1988 Mercury Cougar sustained moderate left side damage from its impact sequence with the Dodge Caravan. The direct contact damage began 8.9 cm (3.5 in) rearward of the left front axle and extended 99.1 cm (39.0 in) forward to the front bumper corner. The combined induced and direct contact damage began at the trailing edge of the left front fender and extended 141.5 cm (55.75 in) forward to the bumper corner. Maximum crush was 50.1 cm (20.0 in) located at the leading edge of the left front fender, 61.0 cm (24.0 in) forward of the left front axle. The crush profile was as follows: C1=0, C2= 13.0 cm (5.1 in), C3=22.9 cm (9.0 in), C4=34.3 cm(13.5 in), C5=35.8 cm (14.1 in), C6=27.4 cm (10.8 in).

107. Close-up view of the direct contact damage.

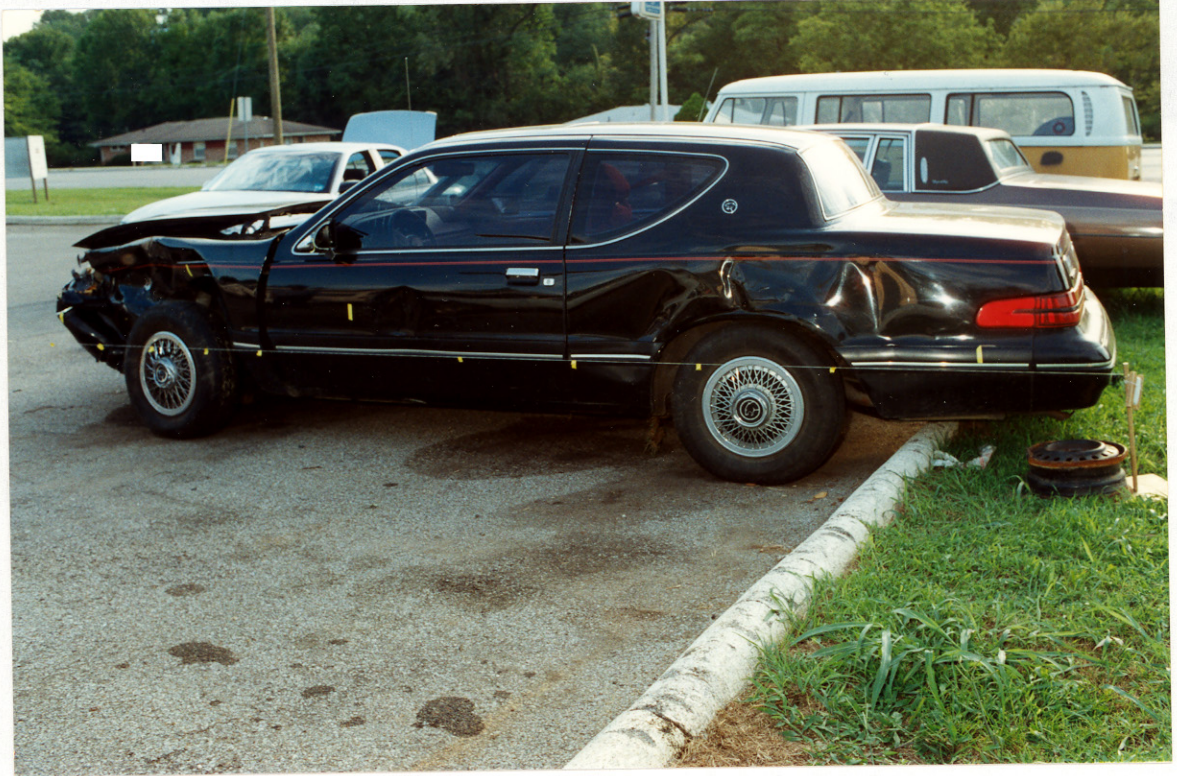
111. View of the primary contact deformation.
